Panel Annals

Part 2: Out with the Old

Editor's note: The following is the second installment of an ongoing series that chronicles a professional panel upgrade on a single-engine, legacy aircraft; in this case, the author's 1979 PA-28-236 Dakota.

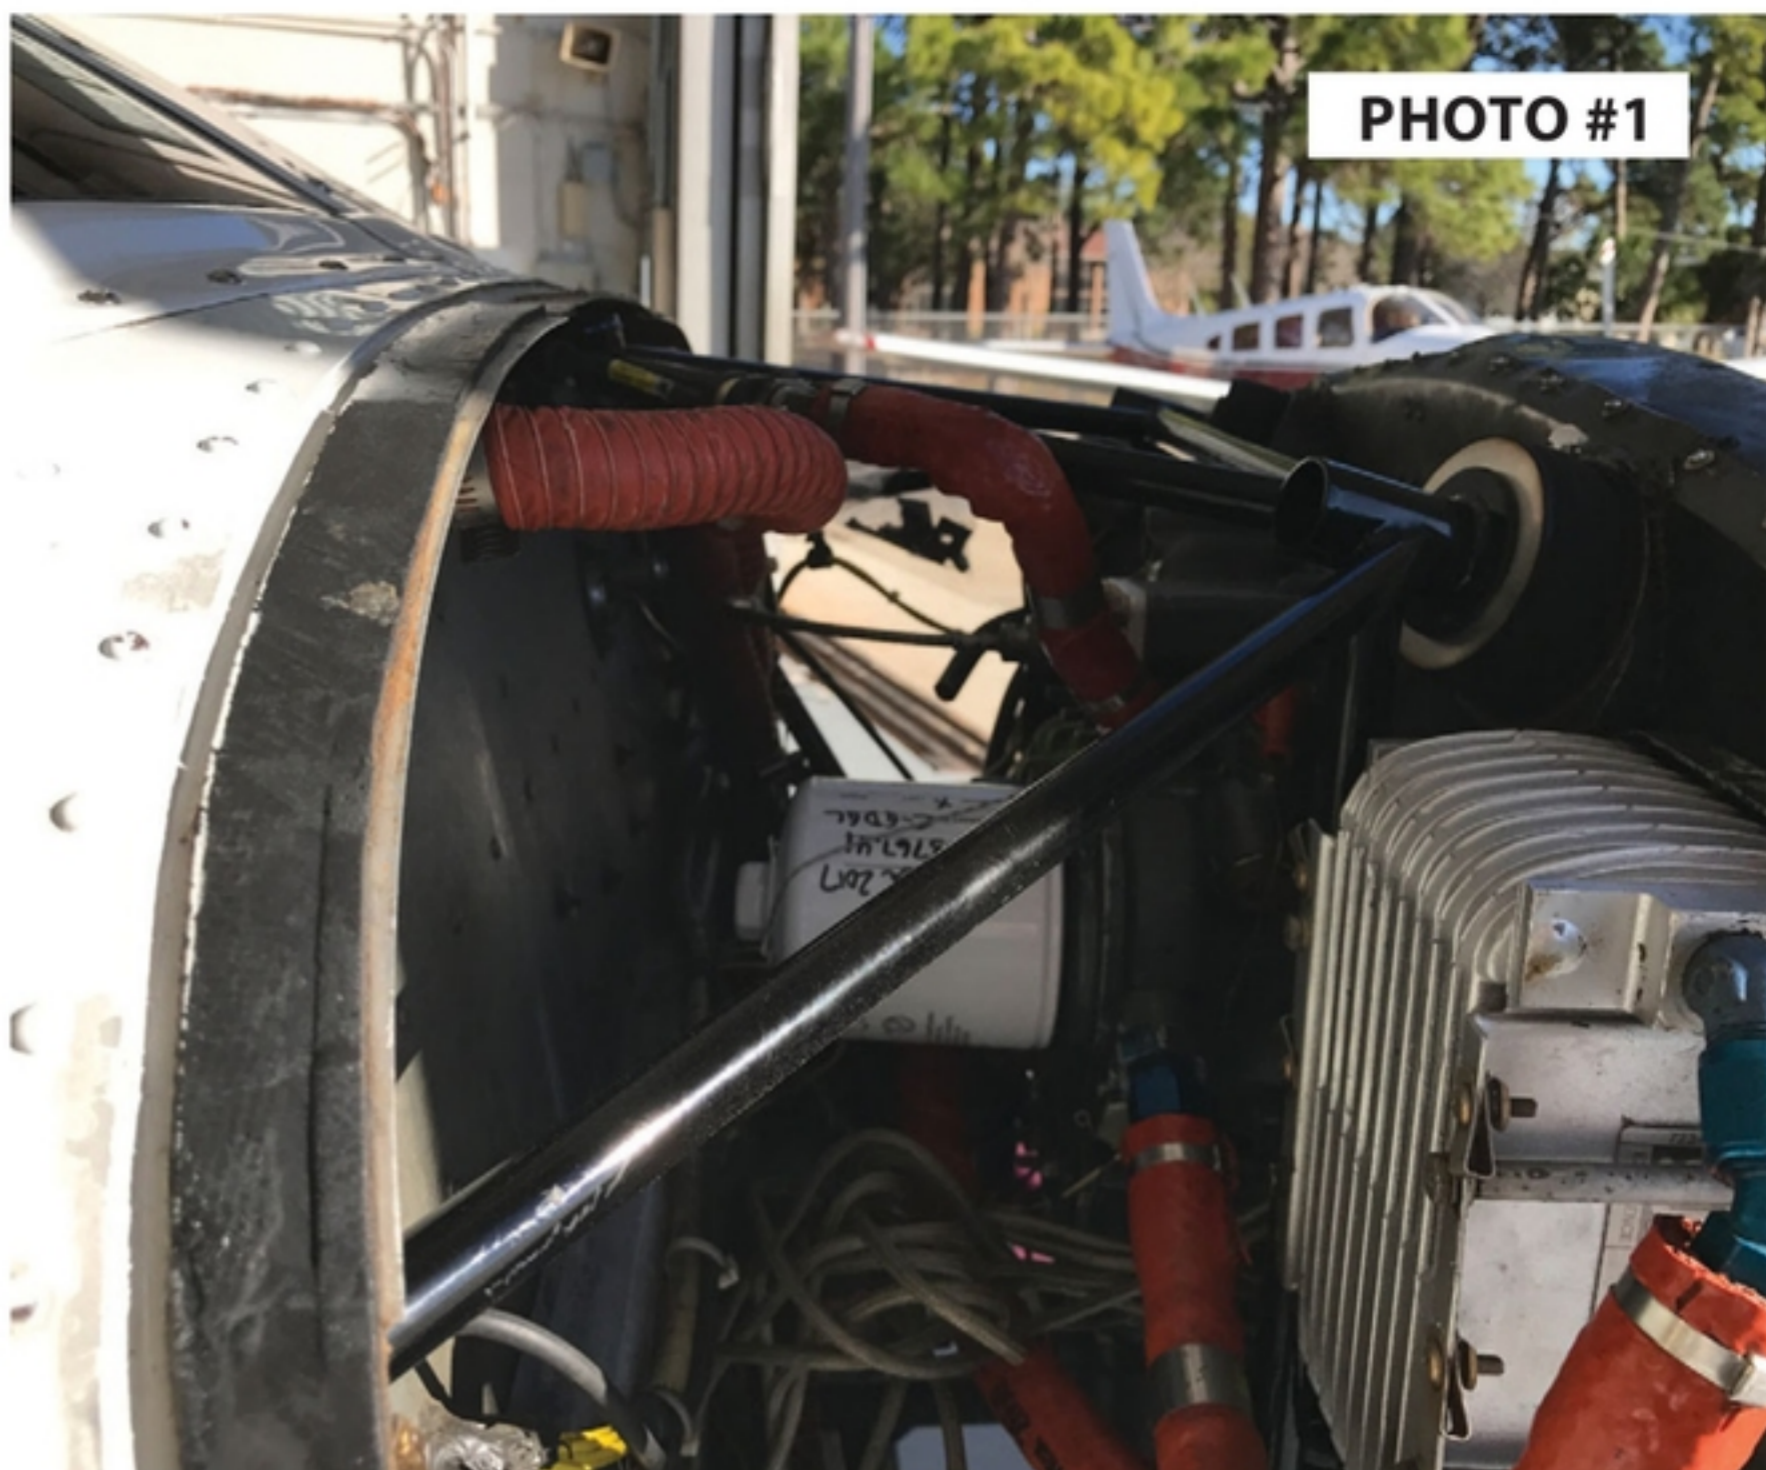
This photo shows the “hole” where the magneto should be.

A review of our records, however, indicated that our plane’s magneto was getting near overhaul time, so we opted to have it removed and sent away for overhaul.

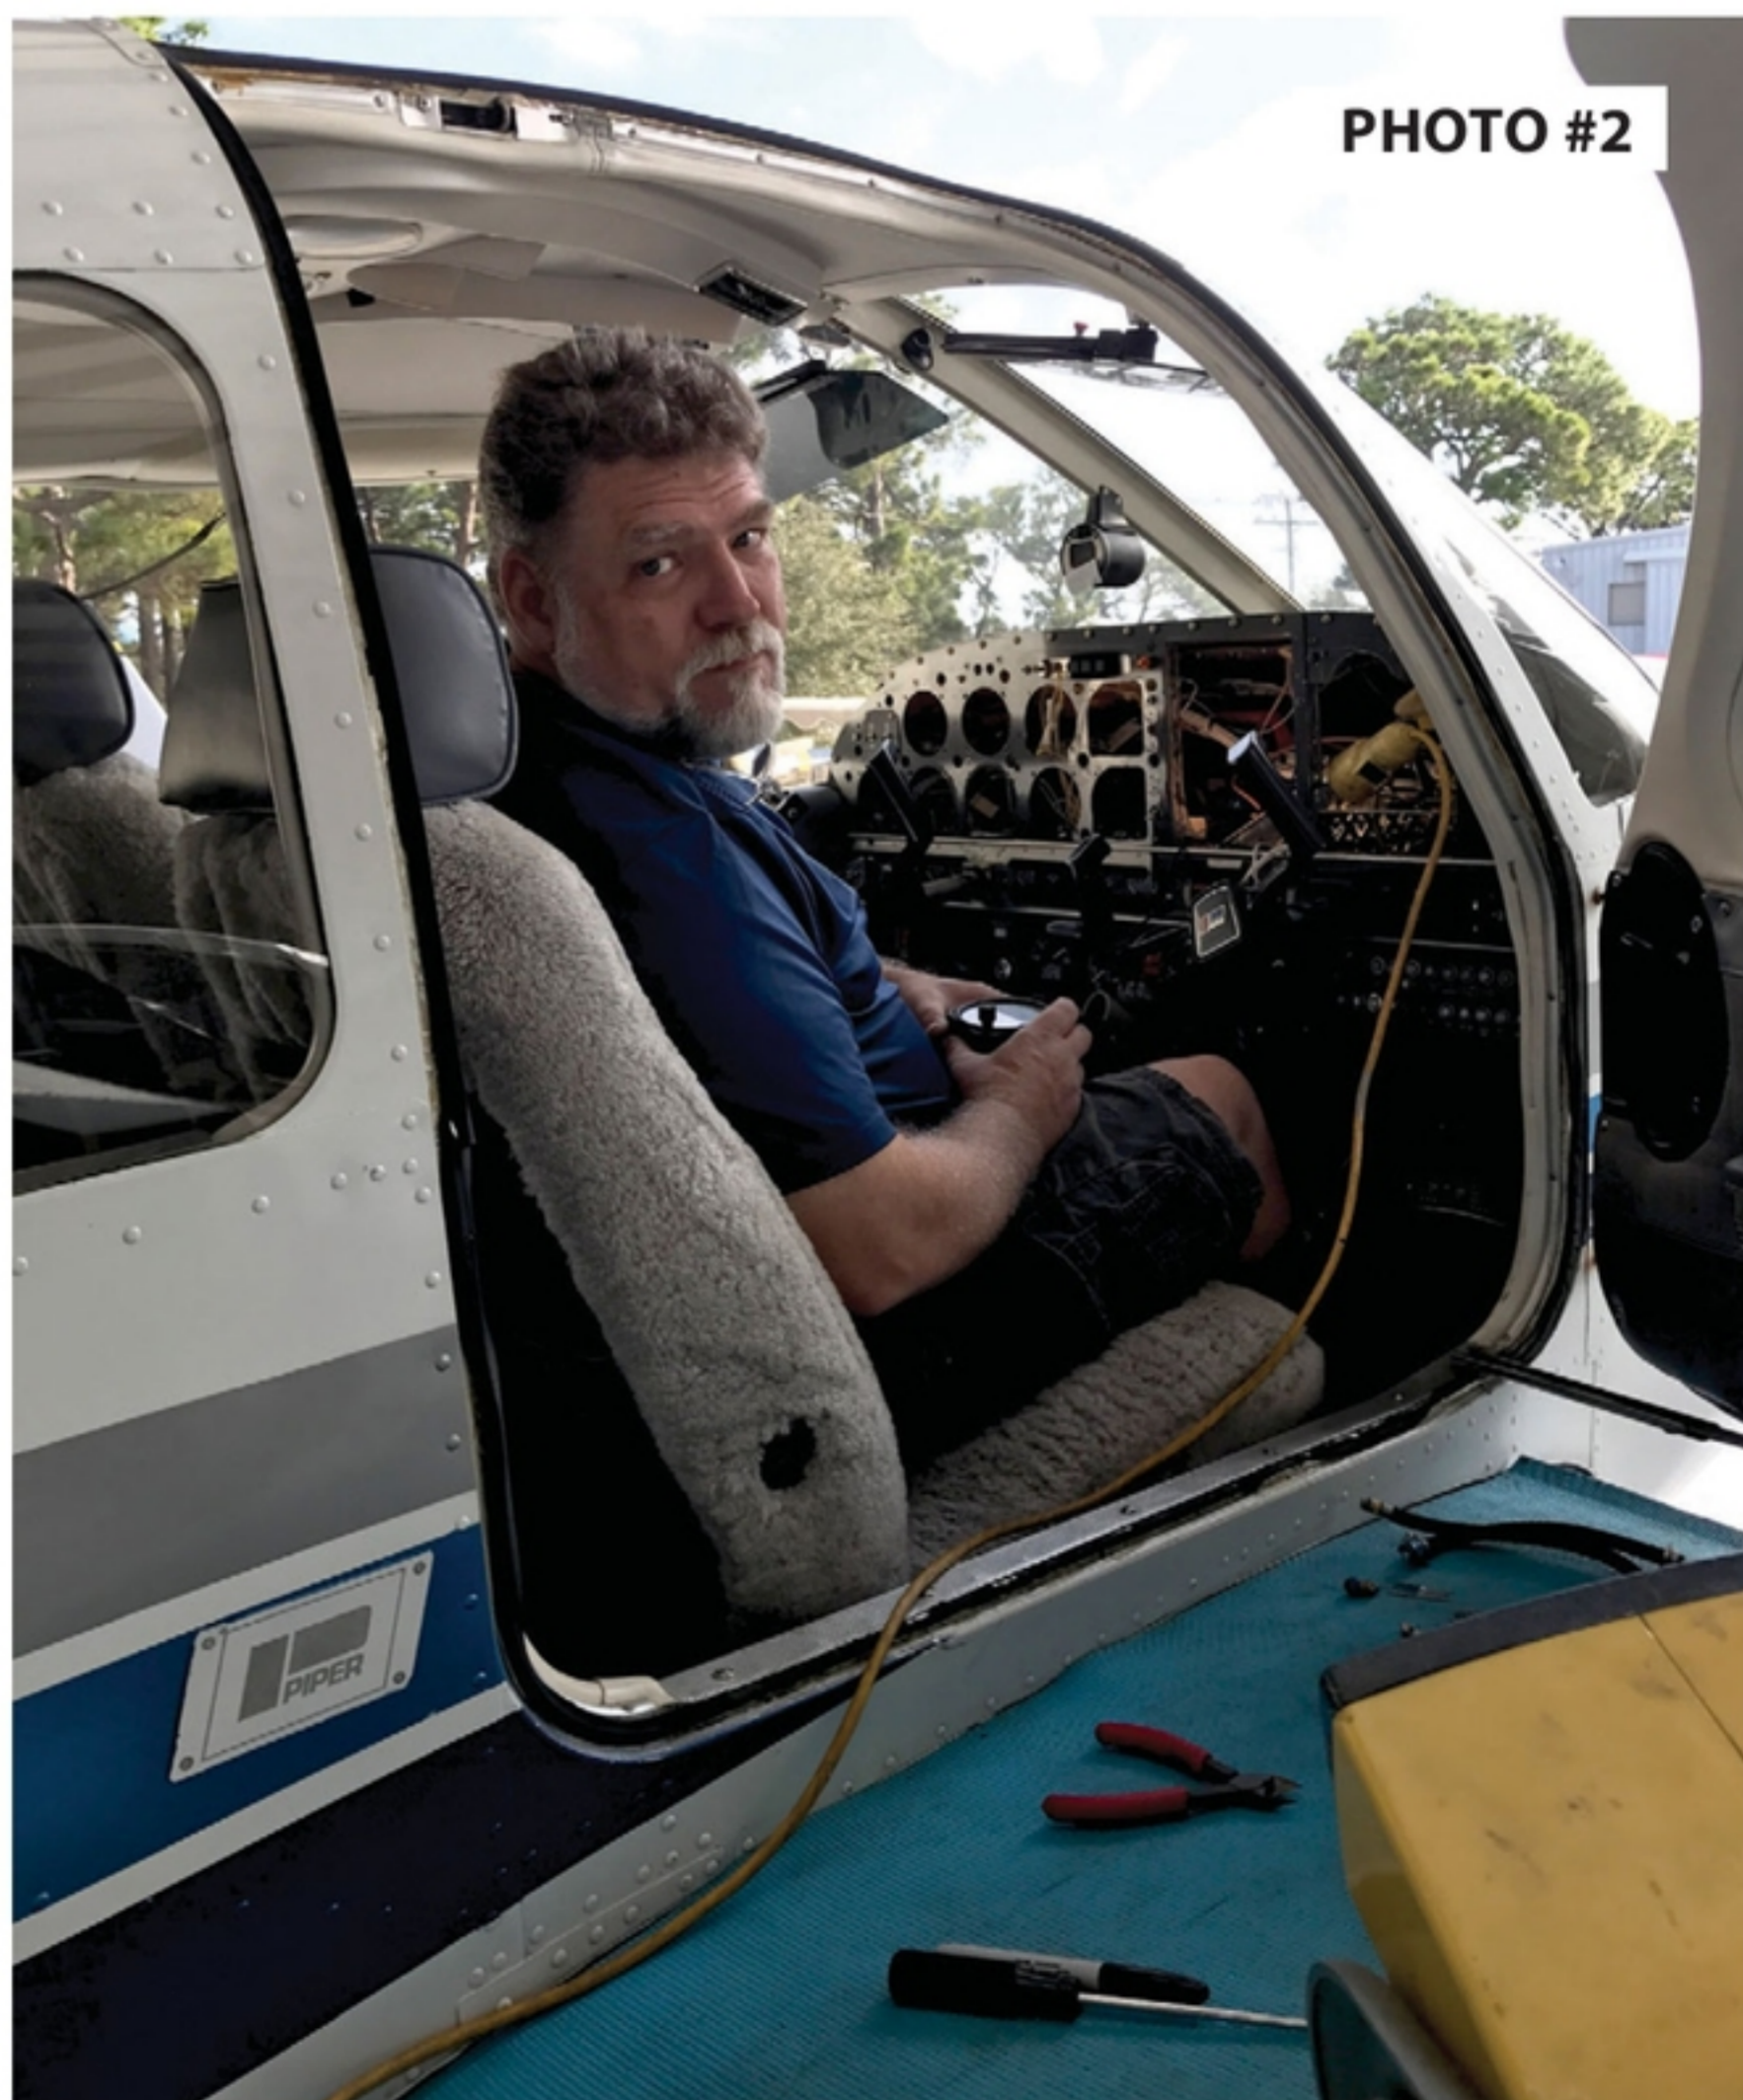
Sarasota Avionics’ Dan Albert hard at work dismantling the panel and removing all equipment.

Following the run-up and magneto removal, the airplane was moved from Sarasota’s maintenance hangar to their avionics hangar. Once there, technician Dan Albert began the task of removing all equipment from the panel.

Dan commented to Paul that the panel and associated wiring were pretty typical of a 1979 vintage airplane that has had modifications over the years. To complete his work, Dan would sit in the right seat and place all of his various tools on a thick blue mat on the wing. Then he got to work methodically removing items from the panel.

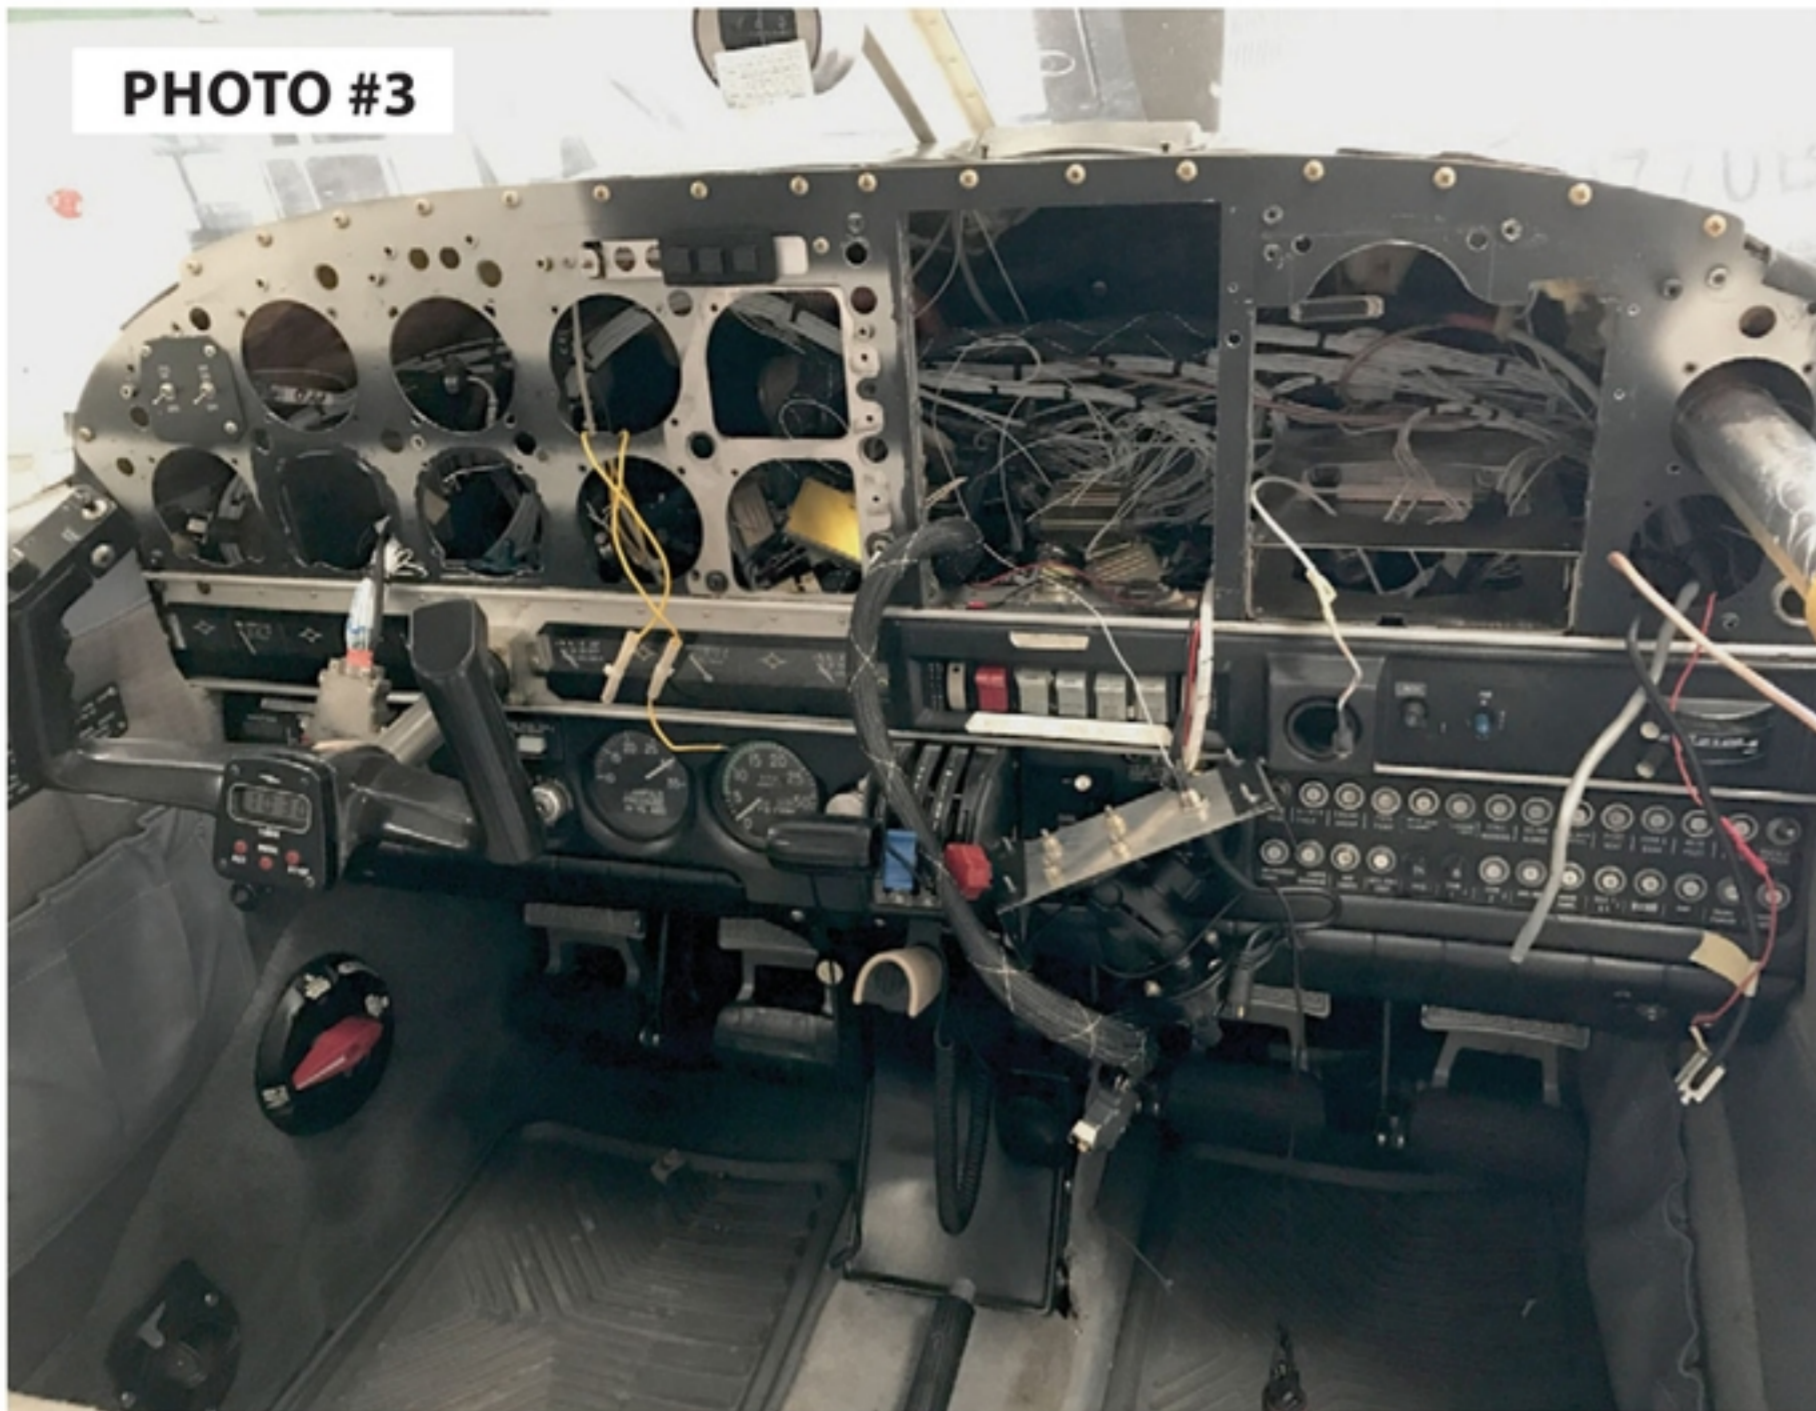
Looking pretty bare!

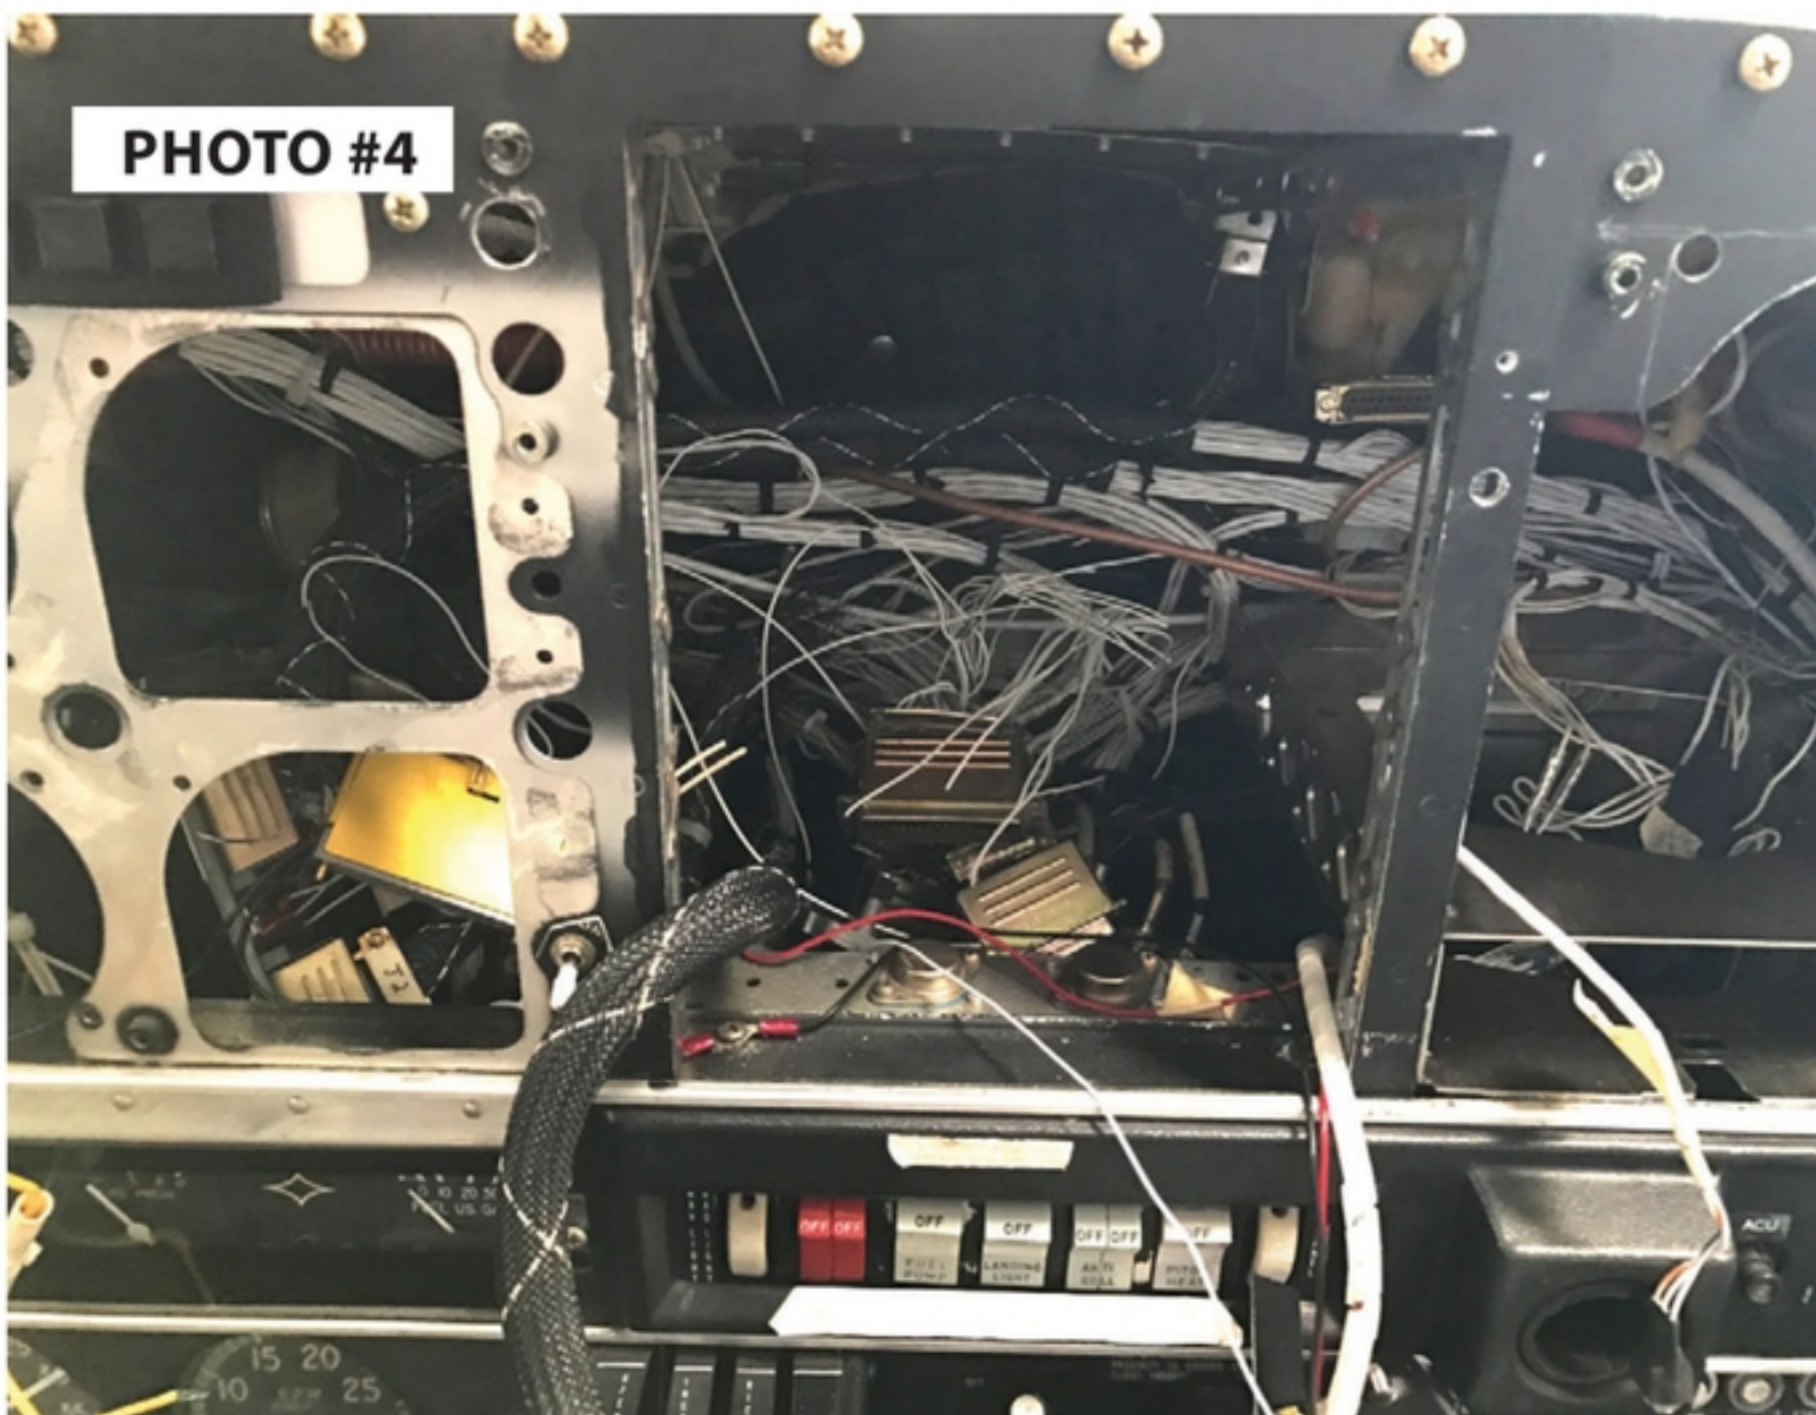
What will fill all those holes? And what connects to that rat's nest of wires?

Naturally, some of the equipment being removed will not make its way back into the panel as part of the project. In those cases, we have been assured that all accompanying items (including wiring and any antennas) will also be removed. As a result, the airplane will be completely rewired.
